Alumni Hall at Georgia State University

Background

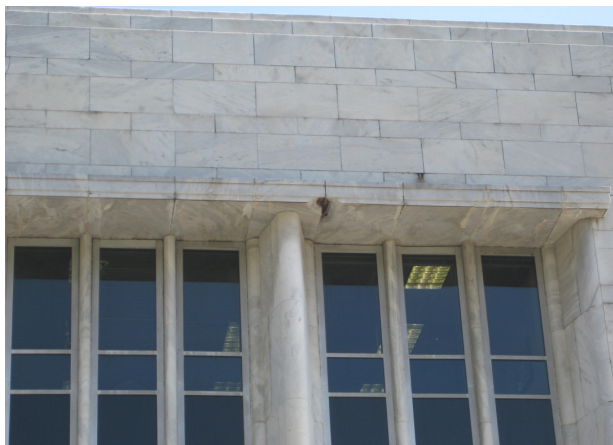
A TEC Services Structural Engineer visited Alumni Hall to observe the stone façade and to discuss areas of distress with GSU maintenance personnel. Severe spalling and cracking of the stone façade was observed at the eyebrow near the roof line over the main entrance of the building. TEC Services consulted with GSU via phone conversation to assist in forming an appropriate scope of engineering evaluation services.

Distress Stones at Eyebrow.

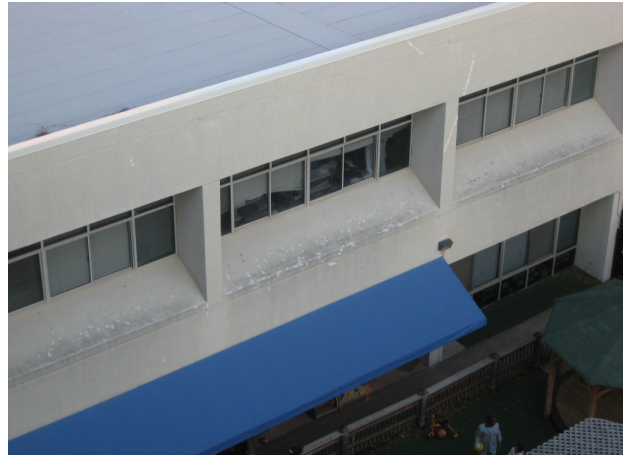
Distressed EIFS facade.

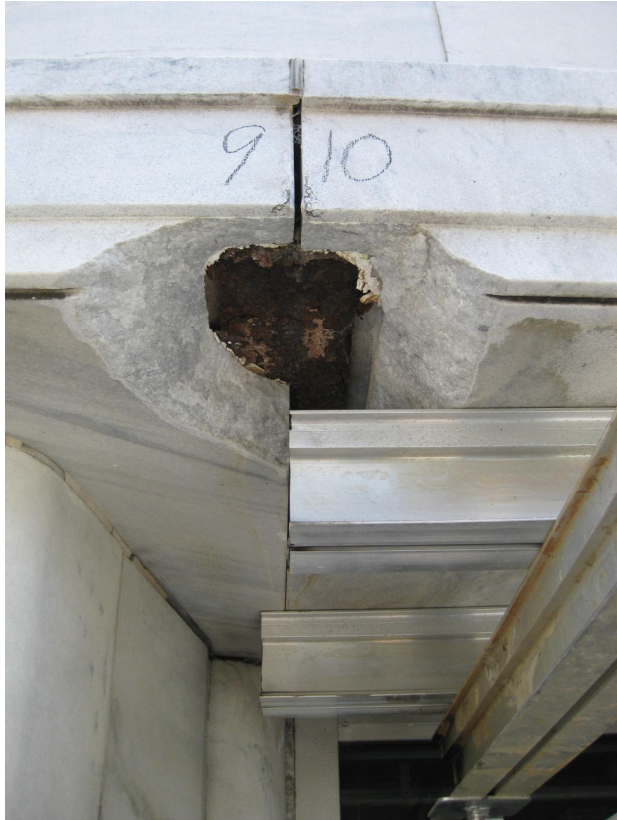
connection methods. Particular focus was directed to stone connections of the front entrance eyebrow which exhibit severe cracks.

Failed Stone at eyebrow.

Close up inspections of the distressed eyebrow stone facade at the front entrance were performed. The stones that required removal and replacement or repair were identified on a plan or elevation view sketch. TEC Services consulted with specialty repair contractors to assist in the evaluation and development of conceptual repairs of the stone facade.
