Structural Condition Assessment at Royal Centre IV (2010)

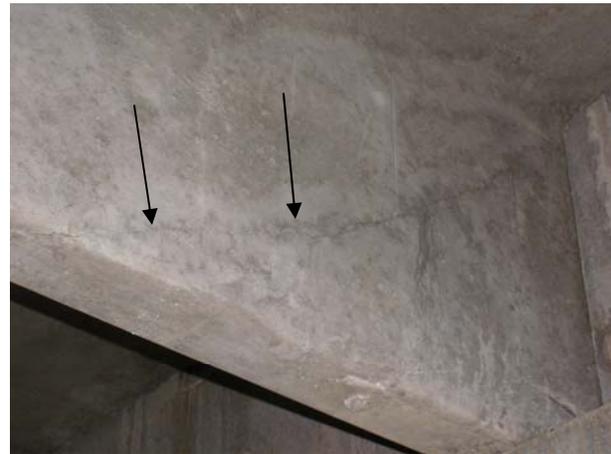
Significant cracks and spalled areas were noted in several double tee beam stems, inverted tees, and L beams. Recommended repairs to these areas included epoxy injection of cracks greater than .016 inches, removing distressed concrete, cleaning any exposed reinforcing steel, and patching with an appropriate repair material. The crack in photo above was recommended for epoxy injection repair.

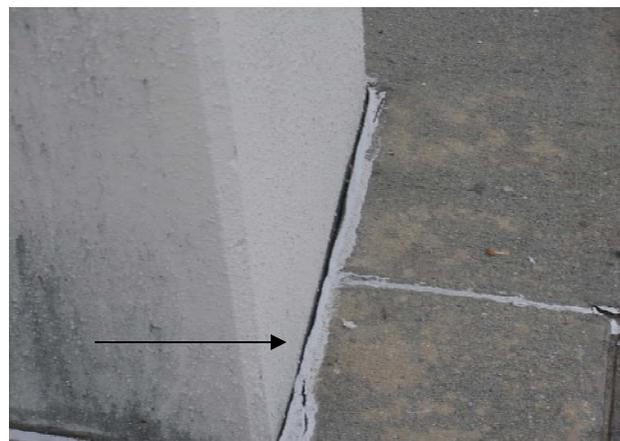
Cove Sealants around columns and perimeter pour strip sealants were missing in much of the parking deck. Cove sealants are recommended at the interface of vertical to horizontal elements to protect from rain runoff infiltration into cracks associated with these interfaces. Existing sealant joints throughout the parking deck were observed to be approaching the end of their service life. They were recommended to be removed and replaced. The photo above is an example of a cove sealant that was not missing but has reached the end of its service life.
