Alumni Hall at Georgia State University

Background

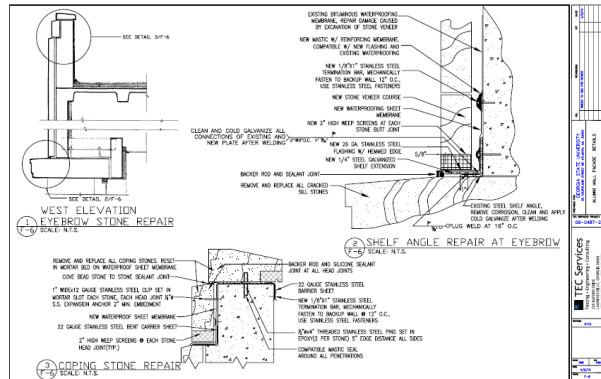
Example Detail Provided by TEC Services.

Based on our findings from our previous work, data gathered from the openings discussed above, and information provided by GSU representatives, we developed elevation view drawings and typical section view details of the recommended façade repairs presented in our previous report. The drawings developed were of sufficient detail to obtain bids and perform the listed scope of façade repairs. Technical specifications were developed for the execution of the façade repair work. We consulted with available manufactures to review currently available products, warranties, and approved applicators. Recommended products were incorporated into the technical specification for review and approval of GSU.
